Kleinschmidt AN/FGC-25 Teletypewriter Set
1977 to *On-going*

Modified AN/FGC-25 in AUTODIN Terminal Installation

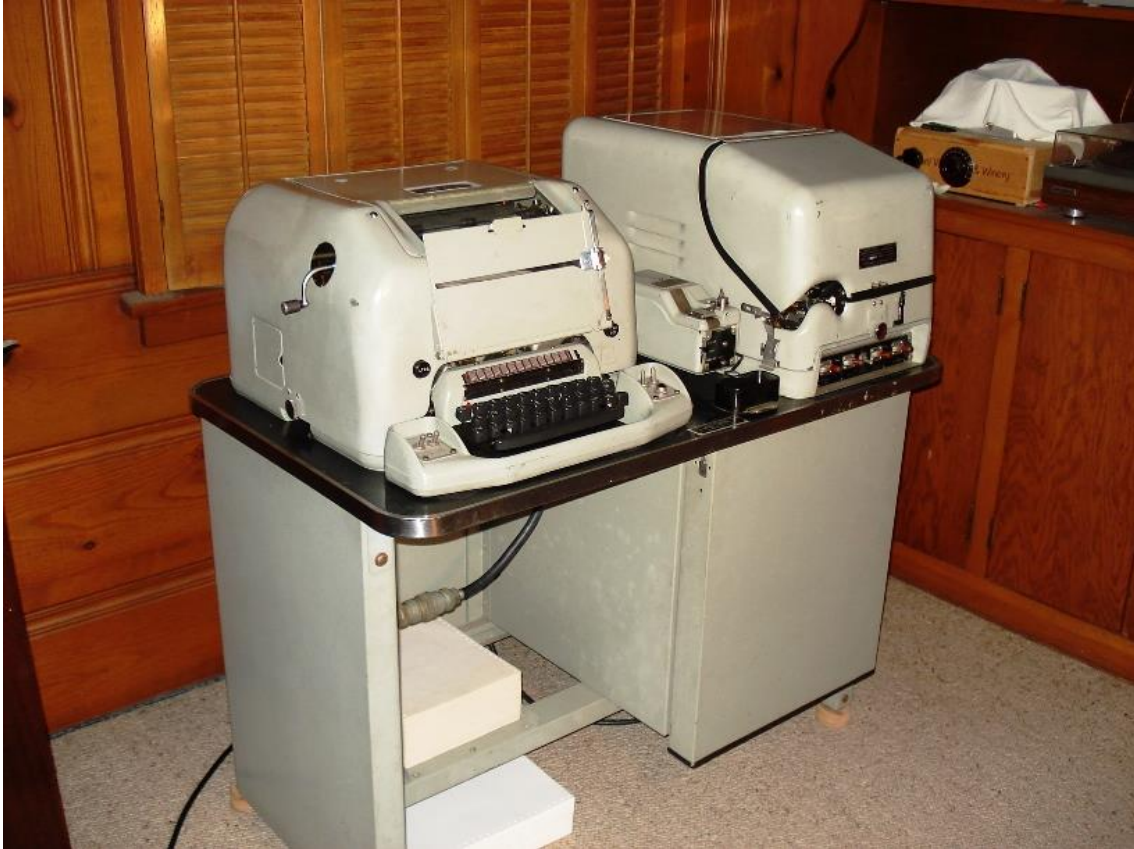
AN/FGC-25 in Our Upstairs Den, April 2014

The ribbons have dried up, I will have to re-ink them or get new ones somehow. All electrolytic capacitors are suspect, due to their advanced age.

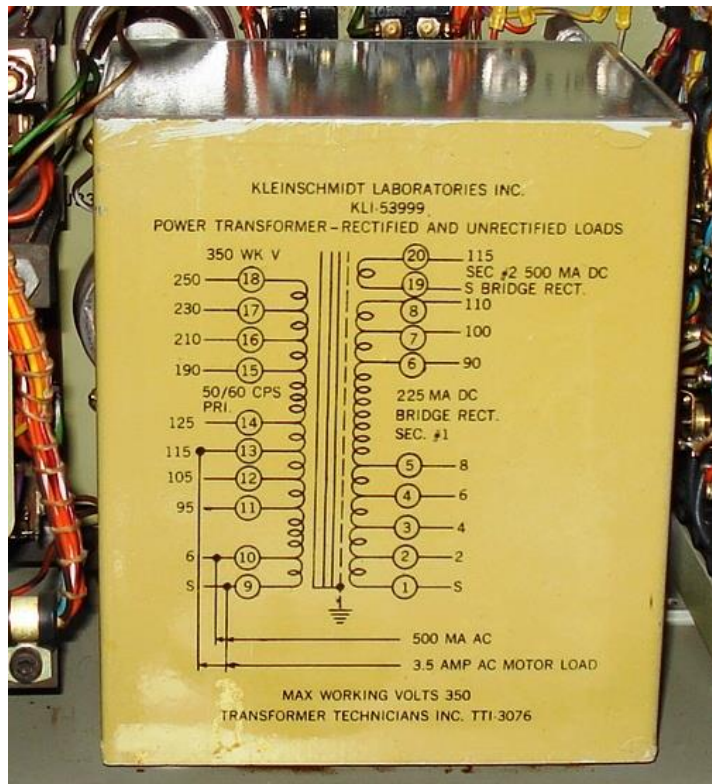
- Detected a discrepancy between the Technical Manual's schematic tap numberings of the power transformer and the diagram painted onto the transformer itself. I think the diagram on the transformer is more likely to be correct. See the close-up photo on next page.

Power Transformer inside the Reperforator Unit

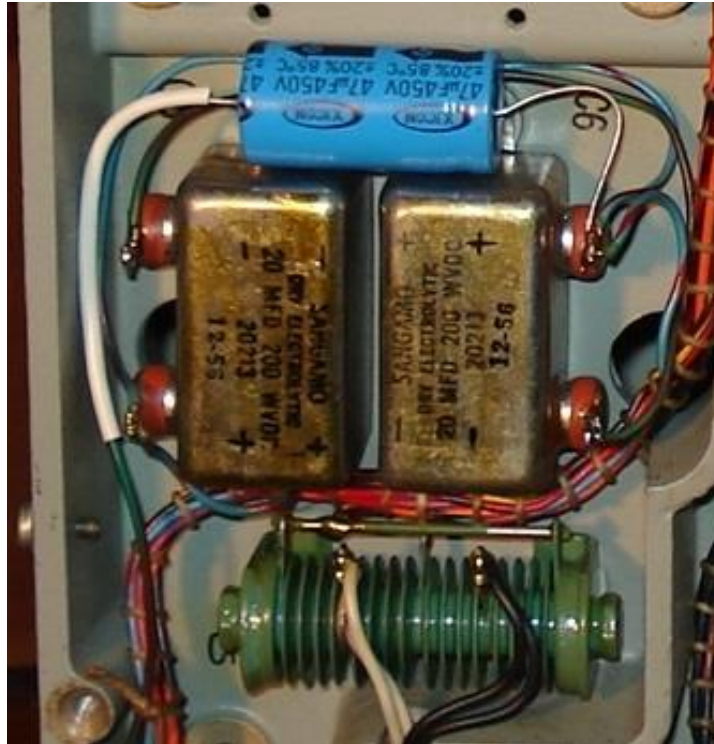
I checked the 1/16 amp (62mA) fuse in the page printer. It was blown. This fuse protects the printer's bias supply. The bias current is supposed to be about 15mA when the printer is operating in 60mA current loop mode. The blown fuse would explain why the printer did not operate. The purpose of the bias winding in the selector magnet is to pull the armature to the "space" position when the 60mA loop signal is a "space", i.e.,

There are two 20uF filter capacitors, C5 and C6, in the printer bias supply. They are the prime suspects for causing the blown fuse. They are wired in parallel to achieve 40uF across the CR1 rectifier output. C5 and C6 are not involved in the simultaneous keyboard mode, so their malfunctions do not explain why that keyboard mode did not work.

March 14, 2015- Three days ago I determined that C5 and C6 must be replaced by testing them this way; I connected C5 to a B battery while monitoring the voltage across it. The B battery output dropped from 56 volts with no load to steady 35 volts when C5 was connected. It should have quickly risen back to 56 volts, so this is a failure indication. Upon disconnect from the B battery, C5 then discharged very quickly. It should have discharged veeerrry slooowwwly, thus another failure indication. Then I did the same test using a known good 47uF capacitor. The B battery voltage did not drop at all, and upon disconnect the good capacitor discharged very slowly.

New 47uF Capacitor Replaces C5 and C6

I replaced C5 and C6 in the circuit with a single 47uF@450 volt unit, but I did not remove them from the printer;

It was necessary to disconnect only one wire from C5/C6 to effect the replacement. Also, you can see that the manufacturing date stamp on each capacitor is 12-56, suggesting that this teletype set was probably manufactured in 1957.

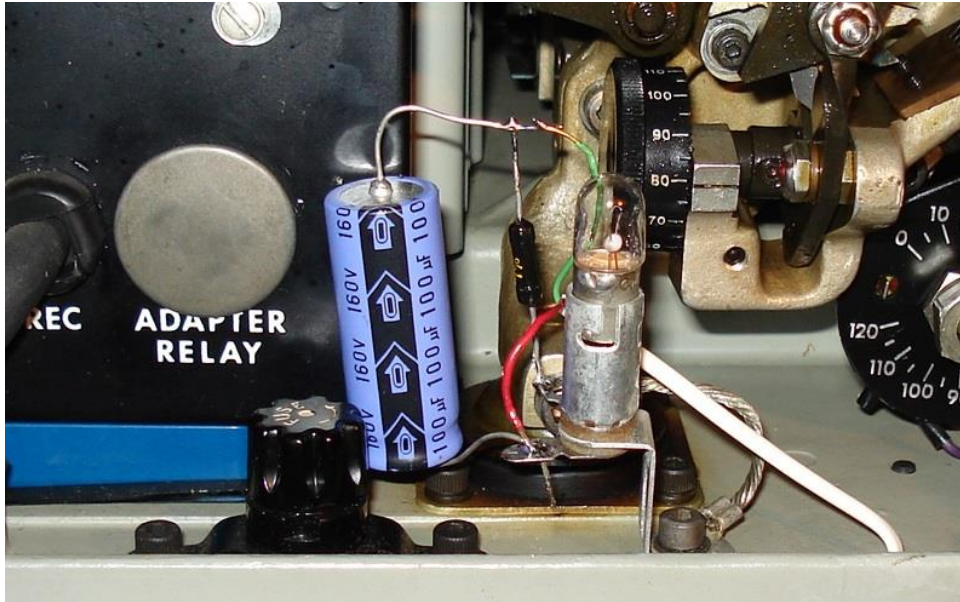
Substitute circuit for 1/16 amp time delay fuse

To replace the 1/16 amp fuse, I wired up a pilot lamp socket across the fuse holder terminals and tried using a #49 pilot lamp. The #49 is rated 60mA at 2 volts, so it should blow quickly if the current greatly exceeds 60mA. I have a few #49s on hand.

The Littelfuse catalog shows that the 1/16 amp time-delay fuse #0313.062 has a cold resistance of 120 ohms. I will add a 125 ohm resistor in series with the pilot lamp. I am going to try reducing the transient turn-on current through the pilot lamp by putting a large value bypass capacitor across the series combination of the 125 ohm resistor and the lamp. The voltage rating of this capacitor should be at least 160 volts, so that

March 21, 2015- The substitute fuse circuit works great. There is no flash of the pilot lamp at turn-on, and the bias current measures correct, at 16mA.

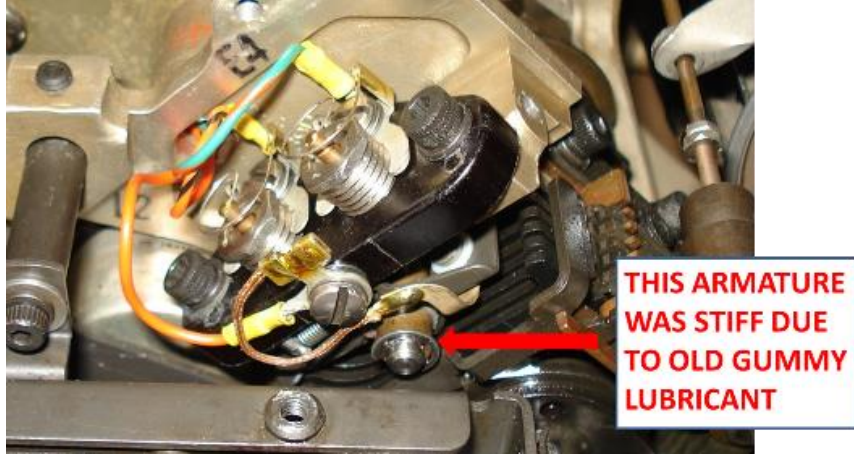
March 22, 2015- This morning I found the problem with the keyboard sequential mode. The E4 mechanism's armature action is very stiff, probably due to old lubricant. This kept it from moving fast enough to perform the break-make operation of the contacts, such that the line mostly stayed in the mark condition regardless of the key code.

Keyboard Unit, E4 Mark/Space Contactor Mechanism

The E4 switch contacts were very dirty with carbonization. They cleaned up nicely with carbon tet solvent swab. I then used extra-fine grit modeler's sandpaper, lightly, and cleaned again with solvent and a cloth wipe.

I had to 1)remove the printer mechanism from the base in order to 2)remove the tabulator mechanism from the keyboard unit, in order to 3)get access to the contact armature for removal, cleaning, and re-lubrication. The armature was so stiff I had to gently pry it off of the pivot using a wooden coffee stirring stick for leverage. It should have slipped off easily.

I shoved a Q-tip soaked in carbon tetrachloride solvent through the inside of the armature shaft to clear out the gummy residue. I swabbed the pivot shaft with solvent using another Q-tip and cloth wipe. I re-lubricated the pivot with fresh oil.

3:30PM- Mission Accomplished. Upon reassembly and adjustment of the E4 contactor, the keyboard sequential transmitter function is now working fine. I typed several error-free lines of text to both the printer and the reperforator. For reasons unknown, the keyboard simultaneous mode seems to be working fine now. I made an error-free tape using it, and played back the tape with no printout errors through the tape reader.

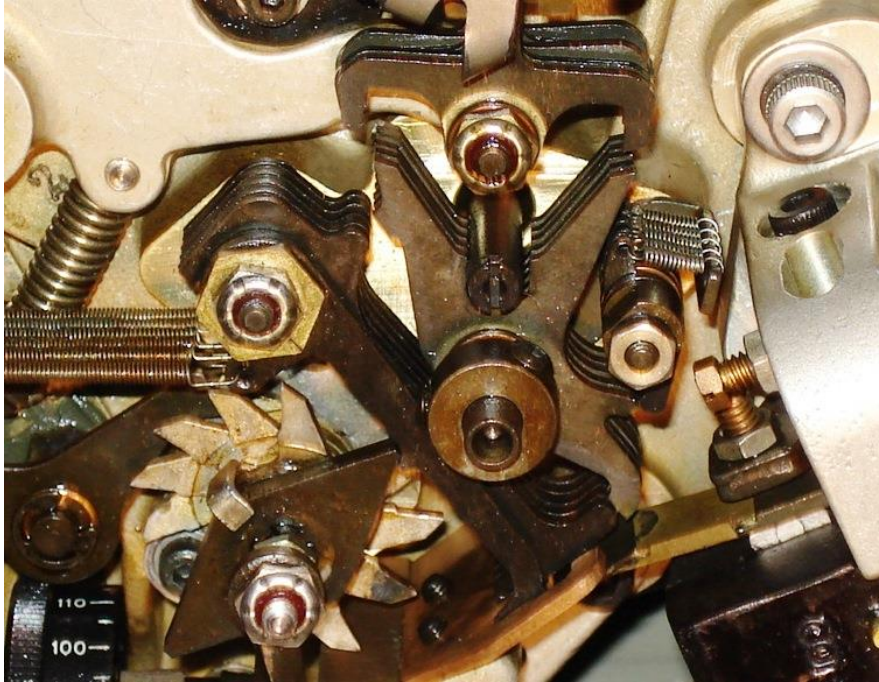
During this down time I took a closer look at the code sensing levers and Y levers of the printer. Their "action" feels a little bit sticky. This could very well be causing the imperfect printing behavior that I have been observing. I will probably have to disassemble them, clean off the old gummy residue, apply fresh lubricant, and reassemble them. If this solves the problem I will probably do it also for the keyboard, tape reader, and reperforator, as they all have mechanisms similar to these.

Left-to-Right: Printer Selector Levers, Y levers, and Y Detent Levers.
The T-levers are above the Y-levers.

April 4, 2015- I used Goof-Off to clean the various parts. I put it all back together and only made one adjustment; the Y-detent levers centering sleeve (Para. 315). I replaced the 4-amp fuse that blew the other day.

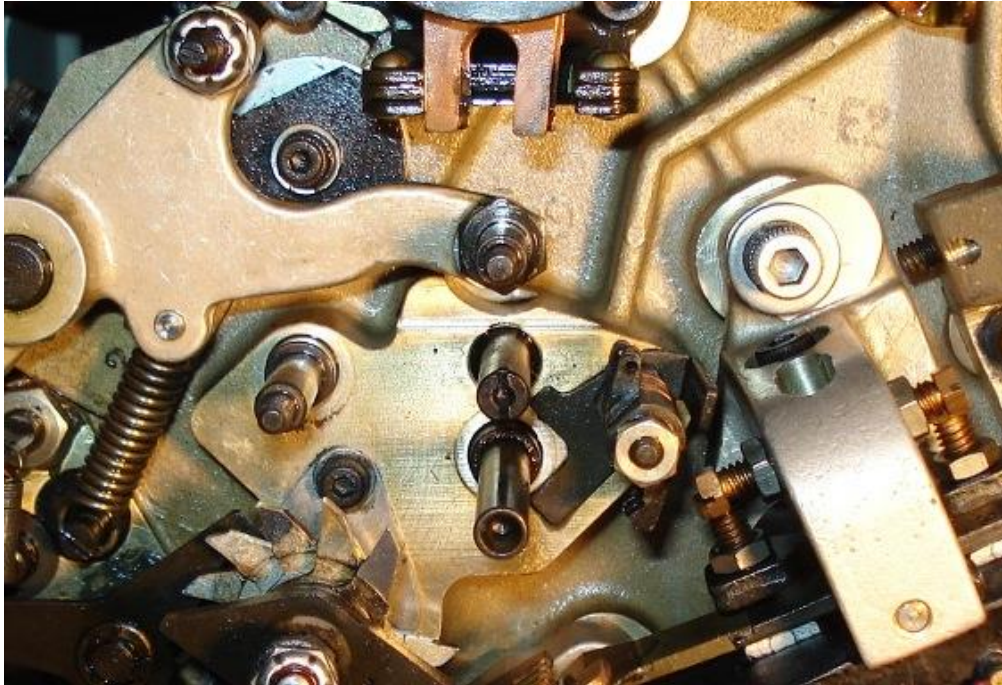
Here is a photo of the same area after I removed the selector levers, Y-levers, and T-levers and their related parts. I removed the Y-detent levers after taking this photo.

The spacing collar and the first Y-lever were quite difficult to remove due to the gummy film on the pivot stud. This gives me hope that this little cleaning exercise should yield much better printer performance.

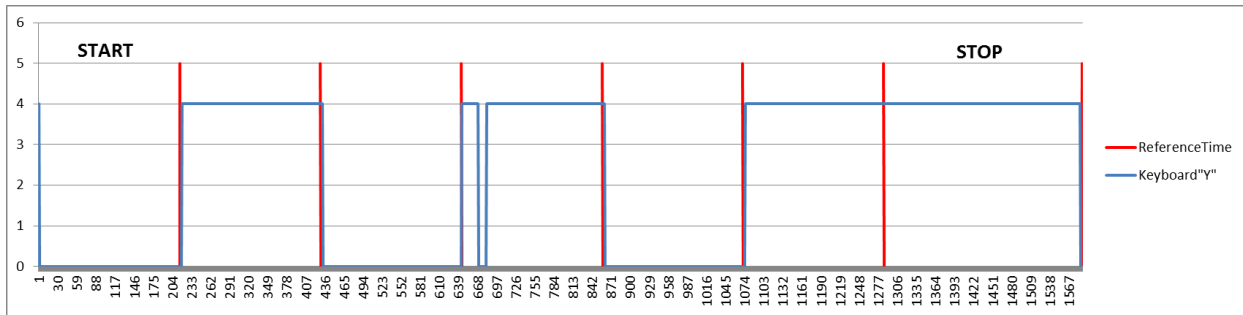
The keyboard timing/bias performance looks great!

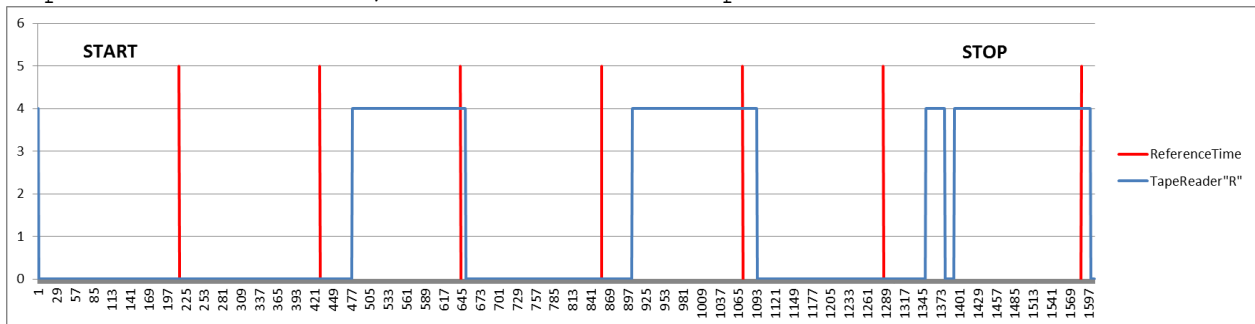
The tape reader's "spacing bias" is clearly evident. There is also some slight "marking end" distortion.

I am wondering if the tape reader's spacing bias might be partly due to heavily worn cam lobes. Perhaps the tape reader was used extensively in this set's previous life, and is showing a sign of the wear and tear?

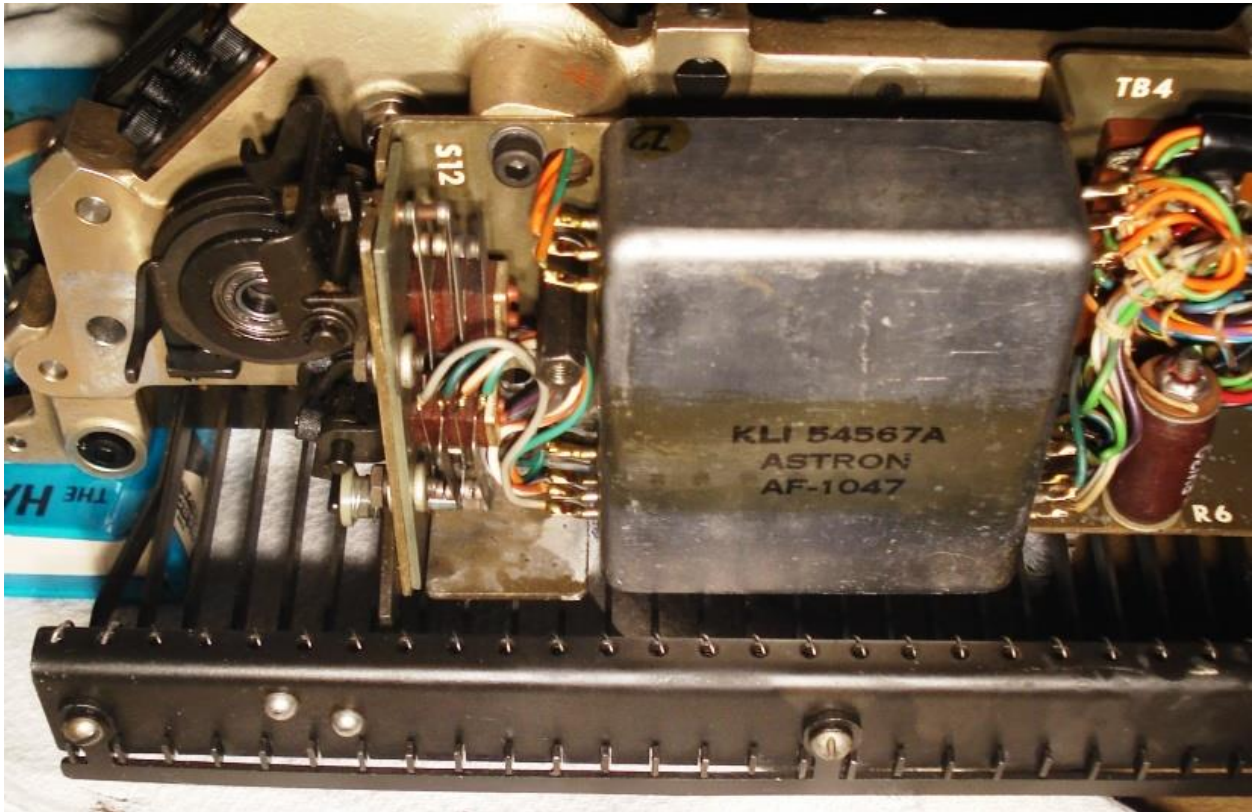
Then I turned my attention to the keyboard assembly and switch S11. I determined that I could check S11 operation manually by attaching an ohmmeter to pins G and H of the printer side of the giant connectors below the printer base and table-top. When I pressed any key the S11 switch resistance was anywhere from 1.8 to 3.5 megohms, when it should have been not more than a handful of ohms. (there are two RF filter chokes in the lines to the cable). I did this test several time by manually operating the L1 solenoid lever. I also had to manually rotate the motor shaft after operating L1, to reset the keyboard so I could press another key. S11 contacts 3 and 4 are very suspect now.

S11 on the bottom, S12 on top, RFI filter module to their right

December 9, 2020- Morning- 8 a.m. I was finally able to inspect, clean and test S11. I used contact cleaner, paper towel strips, and a burnishing tool to clean not only S11 contacts but also S12, since this was a convenient time to do so, even though S12 has been working OK. I was able to achieve 1.4 ohms continuity, at the end of the cable, for the previously bad S11 contacts at pins 3 and 4. This is a very reasonable value since there are two R.F. chokes in the circuit, one going and one coming.

By 10:40 a.m. the printer was all back together and back on the table. "Simultaneous Mode" worked great right away, and the clutch latch arm has been working fine, so far. The video clip demonstration of success is timestamped 10:44 a.m.
