Model 33 - Cover Front & Keyboard Repairs

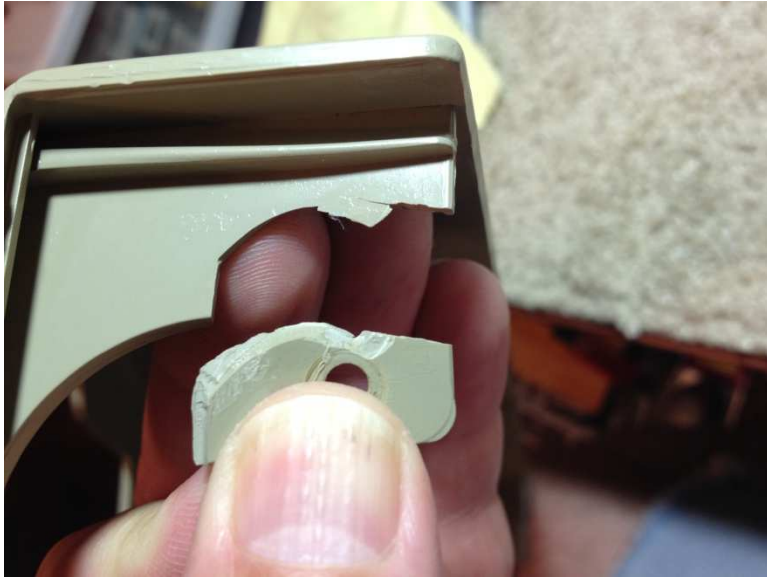
Example of damage to front part of cover.

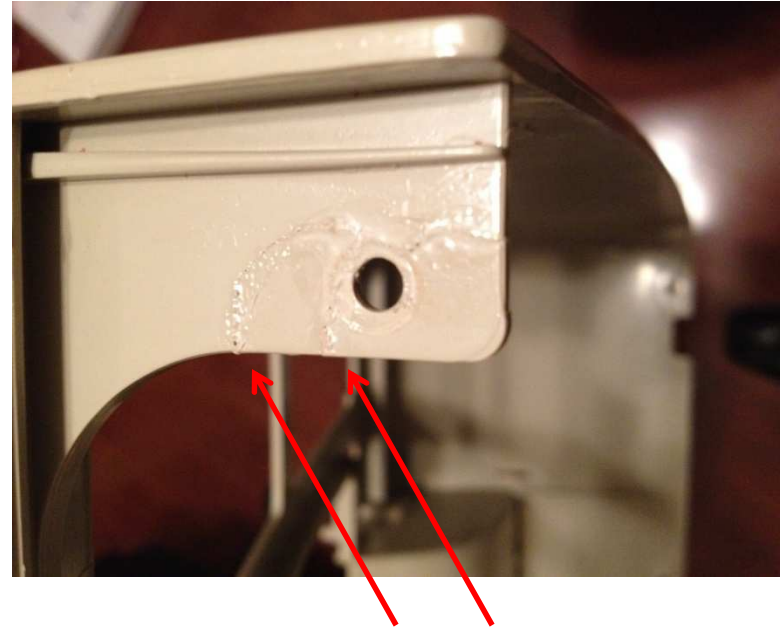
Front View after solvent weld. NOTE:
Two full breaks in plastic.

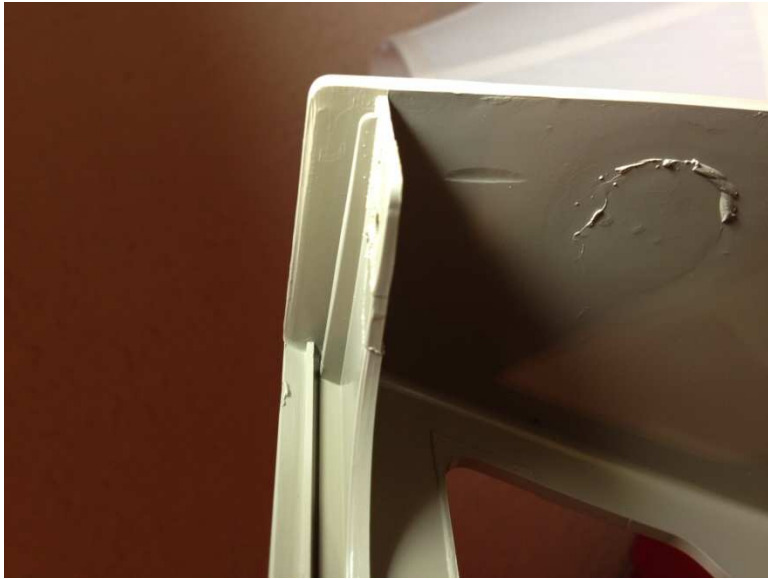
Side view of part after solvent welding.

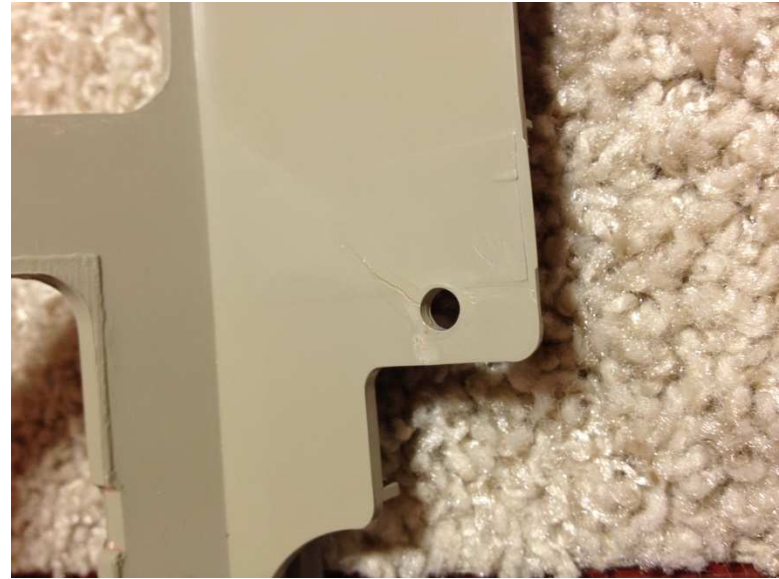
Solvent weld along full-thickness crack in plastic.

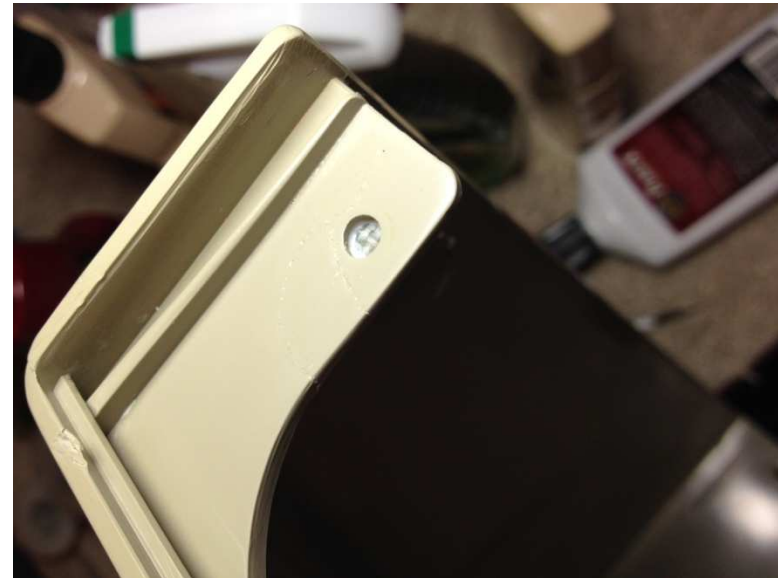
Cosmetics of the front repair after polishing.

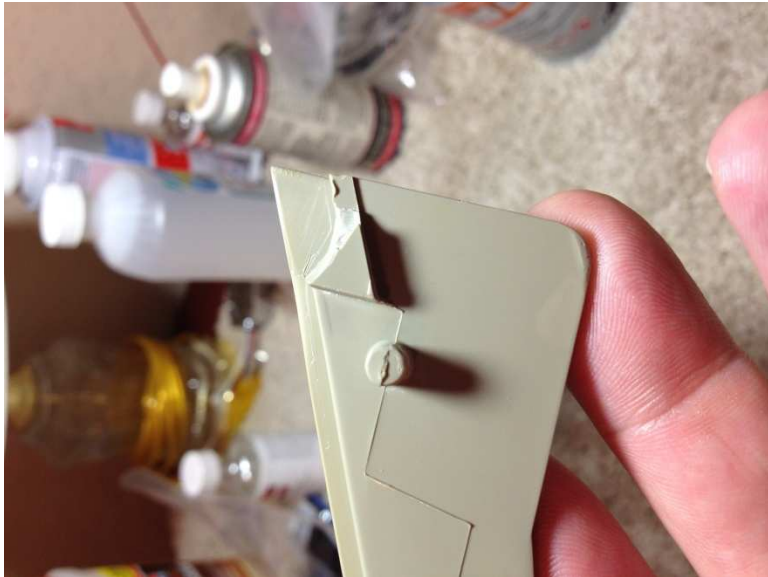
Top right KB cover “ear” found broken off. Piece was missing requiring fabrication of replacement part.

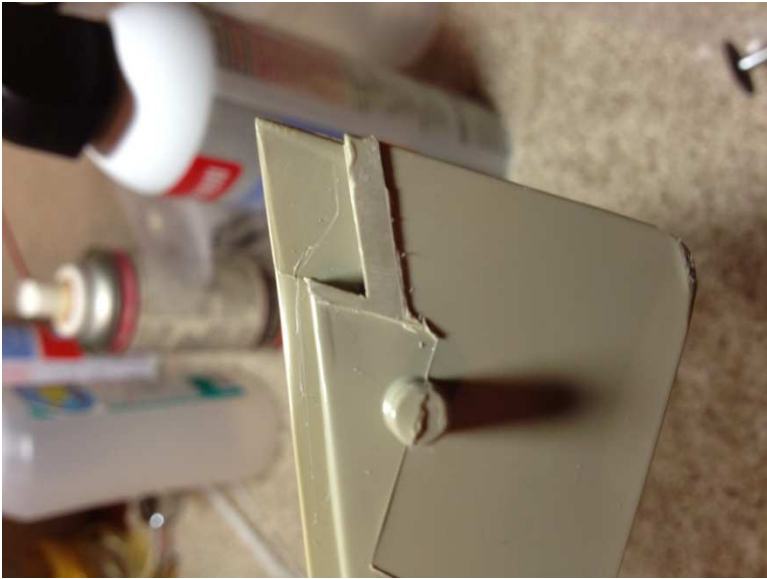
Keyboard cover with entire "ear" removed.

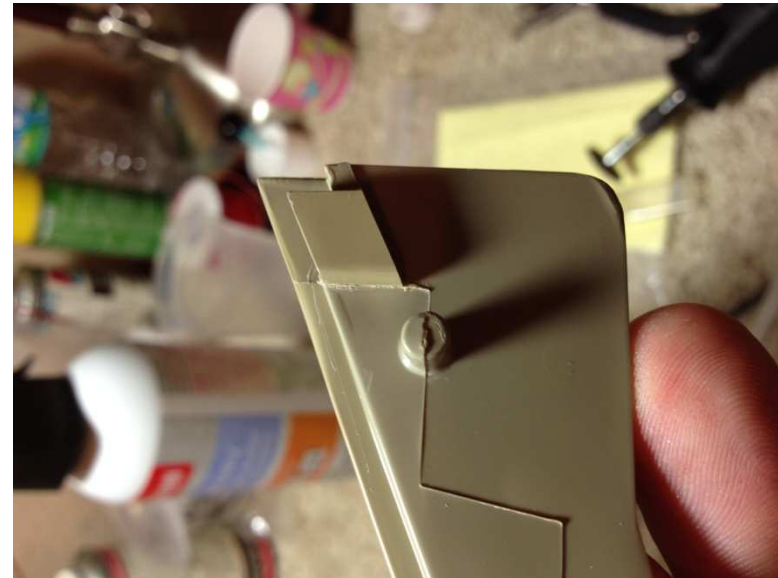
Cosmetics of the “ear” repair after solvent welding. NOTE: repair appears to be exceptionally strong and would be difficult to spot.
