# A direct plug-in solid state replacement module for the 26Z5W rectifier tube of the R-390 and R-390A receiver

Dr. Kurt Schmid, DH3PJ, sigmapert@gmx.de

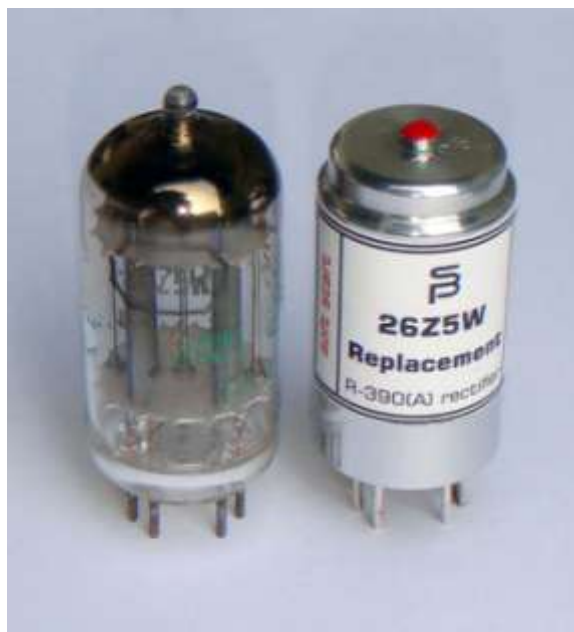
**Fig. 1 26Z5W and 26Z5W replacement module side by side**

In contrast to field change #6 and its hobbyist followers the new device shouldn't need any soldering work in the receiver. Finally, a full plug-in replacement for the original 26Z5W could be achieved (cf. figure 1). If you consider the plug-in module as modification the receiver can be restored to its original state by simple reinsertion of the original 26Z5Ws.

- From figure 1 it's already visually evident that the 26Z5W replacement module is more robust than the fragile original 26Z5W tube
- Significantly reduced power consumption and overall heat production of the receiver
- Longer life-time
- Less prone to rectifier based failure in the power supply
- Eliminates the increasingly hard to find and expensive 26Z5W rectifier tubes

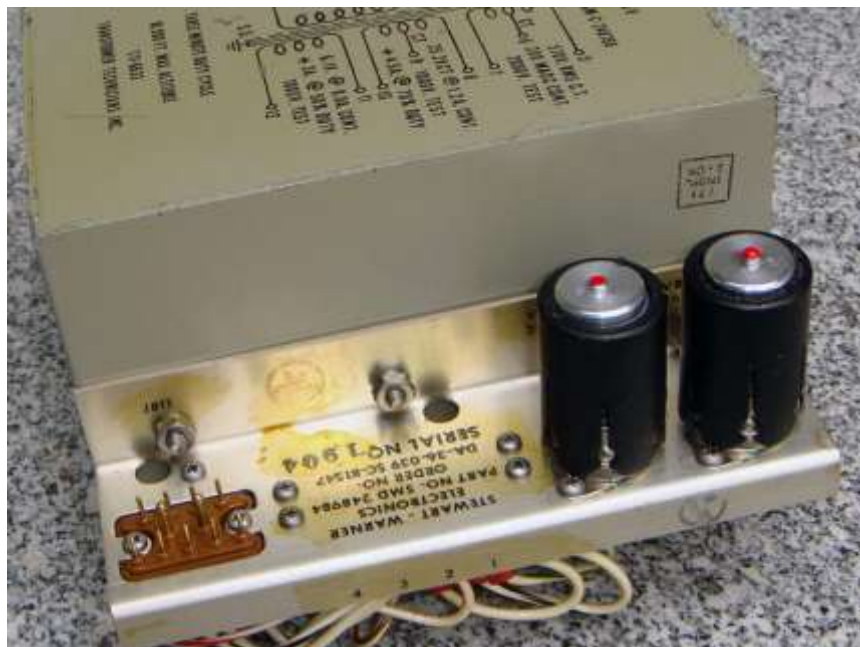
**Fig. 2 Power supply chassis equipped with a pair of 26Z5W replacement modules with short height IERC tube shields (TR6-6015B)**
