Kleinschmidt AN/FGC-25 Teletypewriter Set
1977 to *On-going*

Modified AN/FGC-25 in AUTODIN Terminal Installation

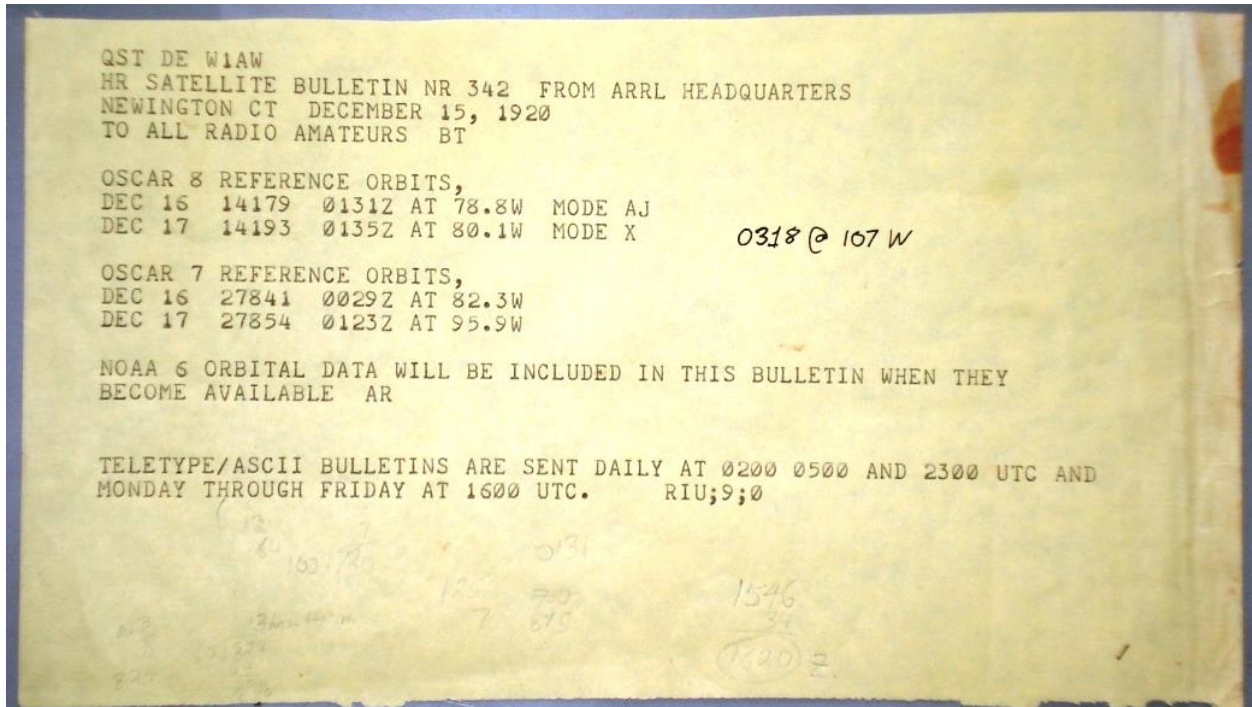
Message Received on my Teletype Set, December 15, 1980
(note one character reception error in the date)

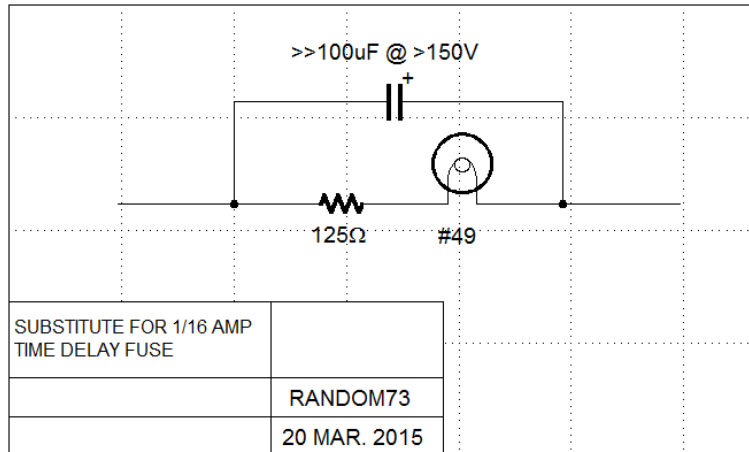
The Littelfuse catalog shows that the 1/16 amp time-delay fuse #0313.062 has a cold resistance of 120 ohms. I will add a 125 ohm resistor in series with the pilot lamp. I am going to try reducing the transient turn-on current through the pilot lamp by putting a large value bypass capacitor across the series combination of the 125 ohm resistor and the lamp. The voltage rating of this capacitor should be at least 160 volts, so that

it can withstand a short circuited load if the lamp blows. At the instant of turn-on the bypass capacitor appears as a short circuit and therefore carries the entire initial inrush current. Its current then decreases as the current through the pilot lamp increases. All the while, the total current is decreasing towards the steady state load current of 15ma as the 47uF filter capacitor is charging. The goal is to get the voltage across the 47uF capacitor to rise much faster than the voltage across the lamp bypass capacitor, by using as large a value as practical for the bypass capacitor.

March 21, 2015- The substitute fuse circuit works great. There is no flash of the pilot lamp at turn-on, and the bias current measures correct, at 16mA.

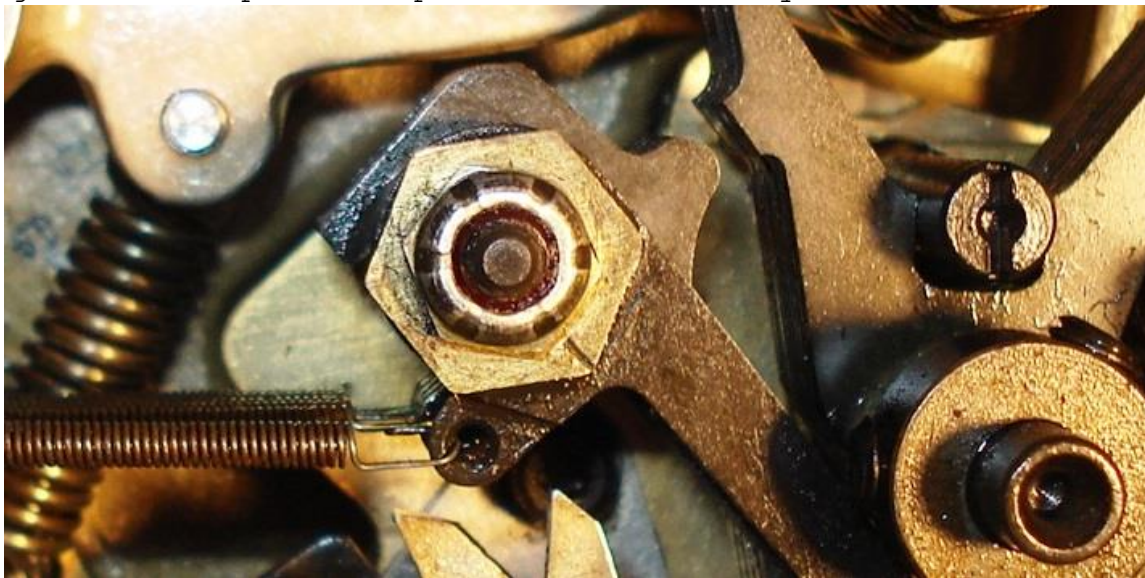
Here is a close-up of the eccentric bearing, showing the alignment mark position prior to disassembly;

The springs for the Y-detent levers are very tiny and delicate. To remove them with low risk of damage I looped a piece of #30 insulated wire-wrap wire through the right side spring hook. Then while holding the wire ends lightly taut with my right hand, I gently pressed my Xcelite R3323 screwdriver blade against the wire, close to the spring, applying a pulling force towards the right, until the spring unhooked from the spring bracket.

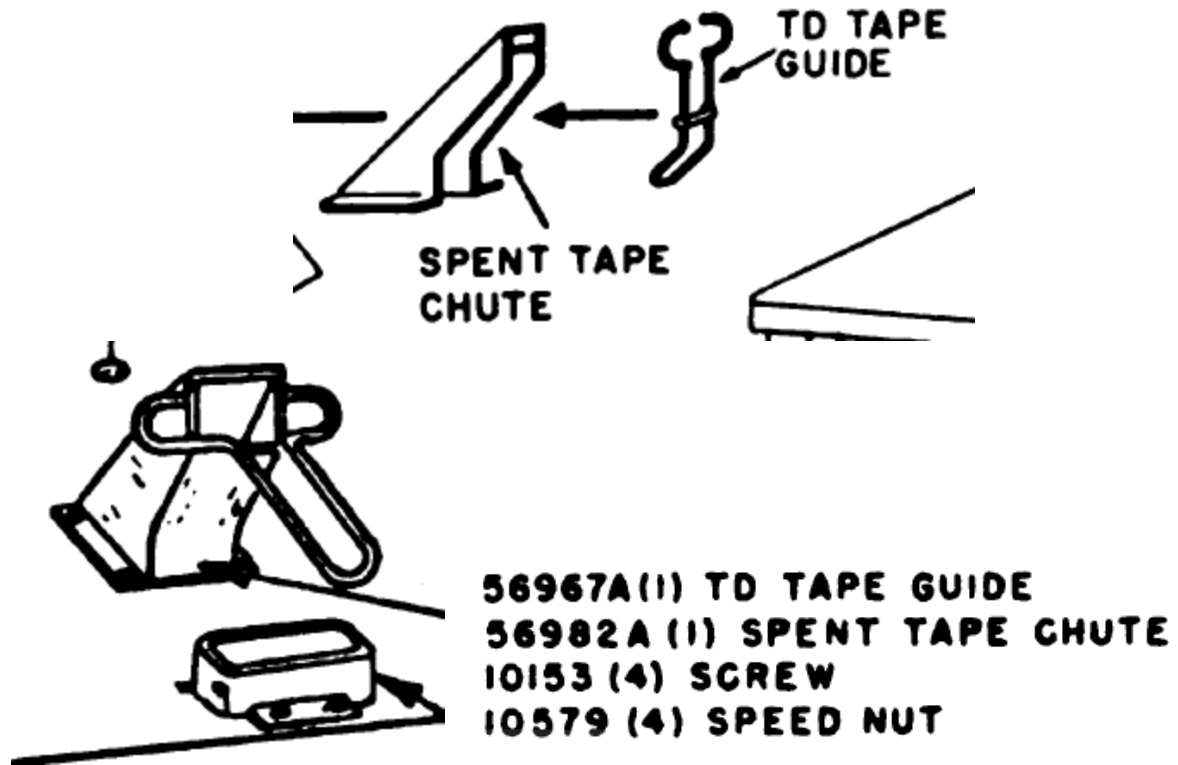
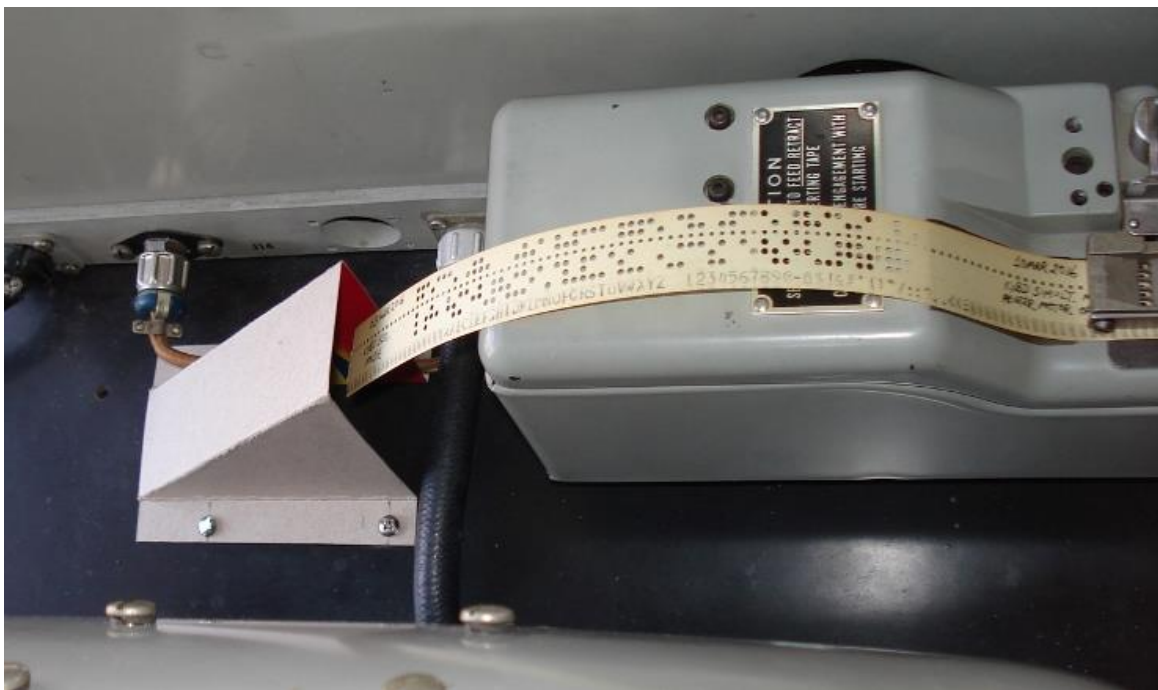
April 24, 2016- My table did not have the "spent tape chute", so I fashioned a rather crude substitute out of a piece of a Ritz Crackers box. I cannot figure out exactly how the part called "TD Tape Guide" is supposed to work, so I haven't tried to make something for it yet. Below are snips from TM11-5815-244-12;

The parts look different in the two different figures. It looks like maybe the looped end of the "TD Tape Guide" is supposed to rest on top of the tape reader?

April 27, 2016- I think I just figured out how the "TD Tape Guide" works. It rests on top of the spent tape chute when not in use. After loading a tape, you flip the tape guide up and over, such that it rests on top of the tape reader.

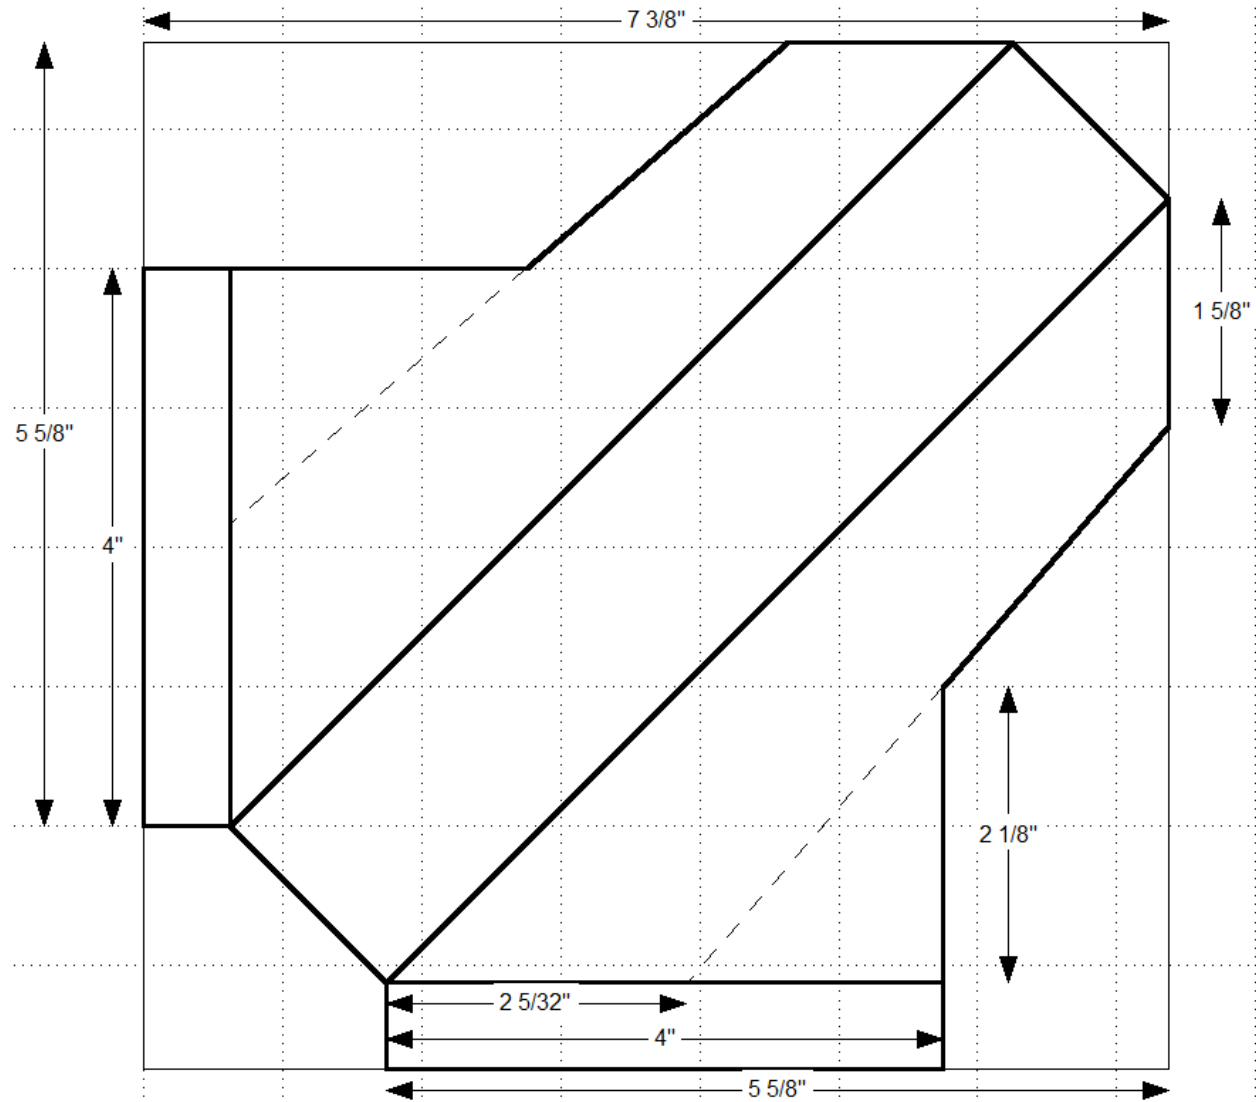
My spent tape chute is not long enough. I need to extend it towards the tape reader about two inches and install a sloping "shelf" for the tape to rest on after it enters the chute.

May 8, 2016- Drawing for spent-tape chute to be made by folding a piece of cardboard;

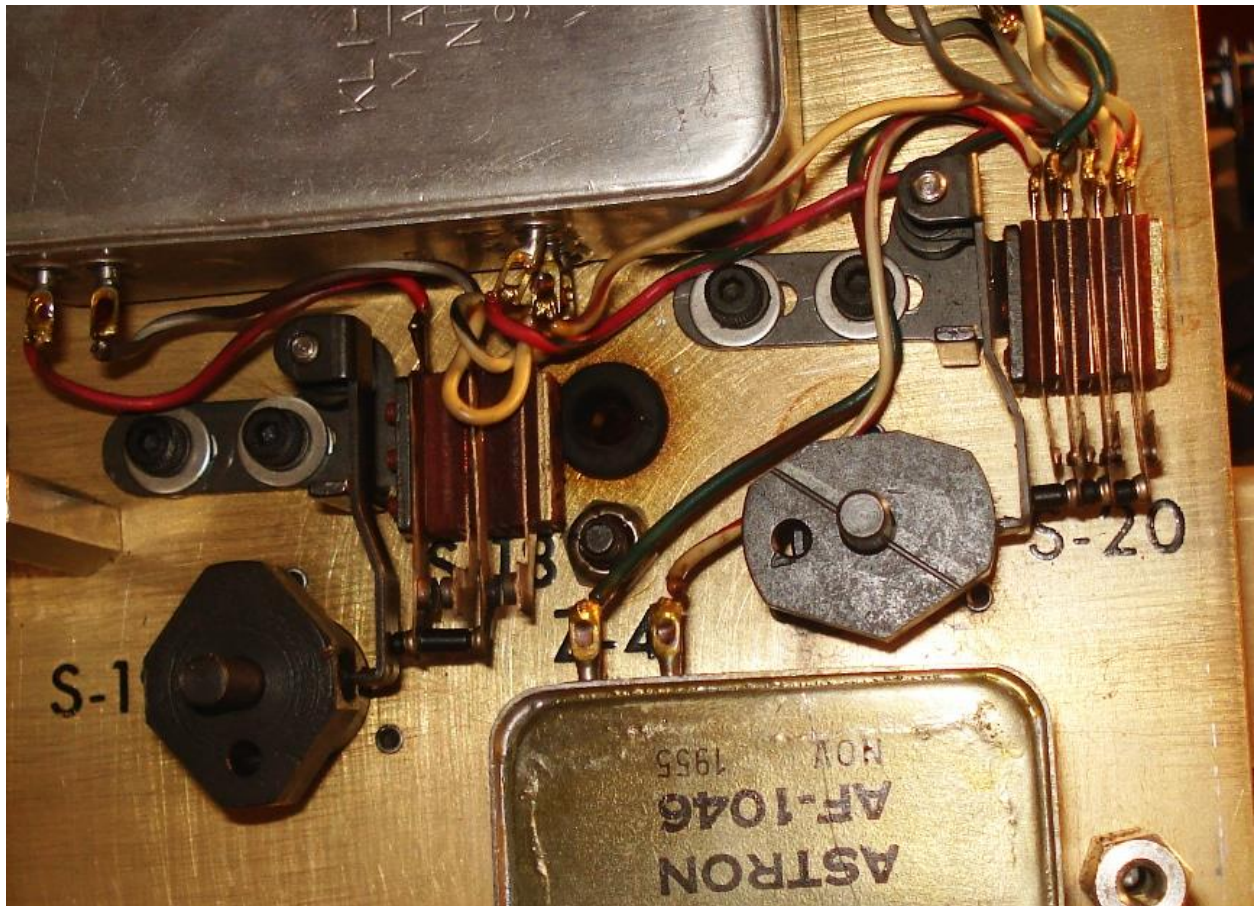
So the first thing that happens when a key is pressed (S11 operates to ON) is that latch coil L3 energizes and releases the clutch. The shaft turns. The attached cam rotates, causing S20 N-O contacts to close, which completes circuit to restoring solenoid L1 in the keyboard. L1 causes switch S11 to go back to OFF, which puts the 500 ohm resistor back into the L1 circuit, effectively disabling L1. Since S11 is now OFF, voltage is removed from L3, thereby disabling L3, so that the latch lever will engage the clutch to stop the rotating shaft when ½ turn is reached. In the meantime, the rotating cam returns the S20 switch contacts back to open.

Somewhere in the TAPE-KEYBD mode there must be some dirty switch contacts. I am pretty sure S18 and S20 are OK now that I have cleaned them and tested S20. If the dirty contacts are S11 3 and 4, then the sequence described above either 1)cannot get started or 2)is intermittent. That is indeed what seems to be happening. The most revealing symptom is the occurrence of 1)no action at all, or 2)a random delay, sometimes very long, between pressing

a key and the activation of L1. If and when L1 finally activates there are also a character printed and code punched onto the tape, which means that the multi-solenoid shaft rotated $\frac{1}{2}$ turn at that same time.

OK - I cleaned all the switch contacts for S18 and S20 and tested the N-O contacts on S20 (the ones that operate restoring solenoid L1 when in simultaneous mode) and they seem to be fine.
